# **DISTRICT INFRASTRUCTURE ASSESSMENT REPORT**

**MYRTLE CREEK IMPROVEMENT DISTRICT**

**APRIL 30, 2026**

**by:  
McINTOSH ASSOCIATES, an LJA COMPANY  
1950 SUMMIT PARK DRIVE, SUITE 600  
ORLANDO, FL 32810**

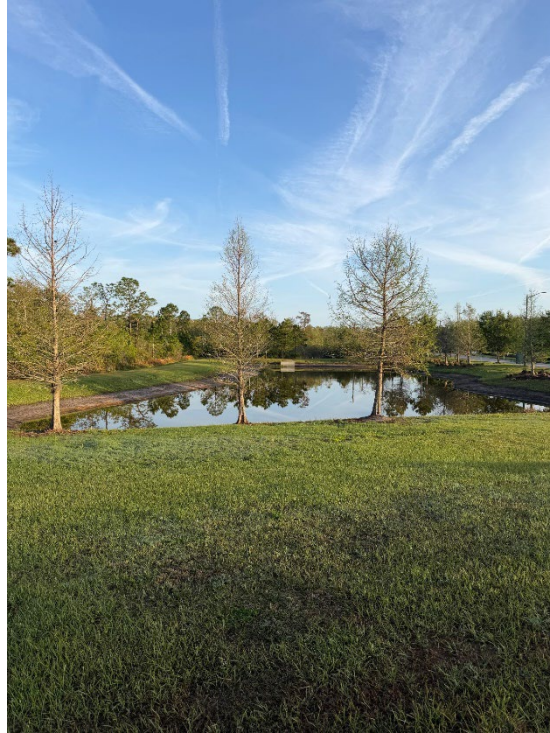
**Photo 1 – Wellspring Drive Pond SMA-WD in Good Condition (No Observed Changes)  
(Refer to Prior Photo 1 - 2025 Assessment)**

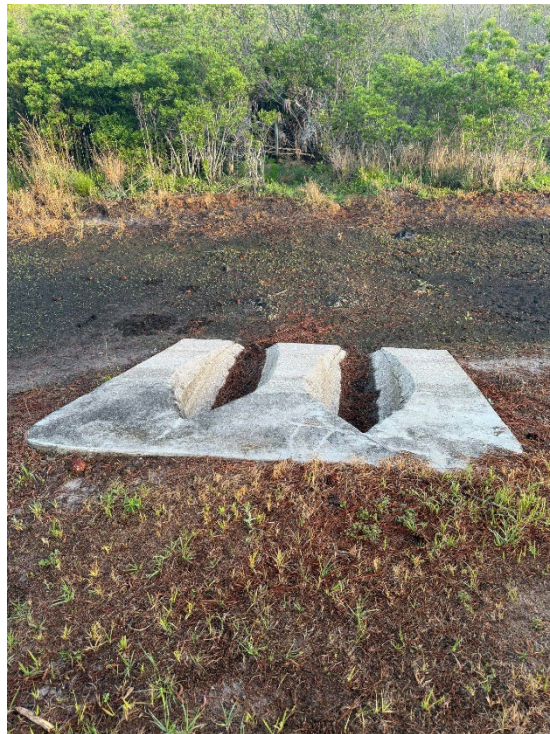
**Photo 2 – Outfall into Spreader Swale in Good Condition (No Observed Changes)  
(Refer to Prior Photo 3 - 2025 Assessment)**

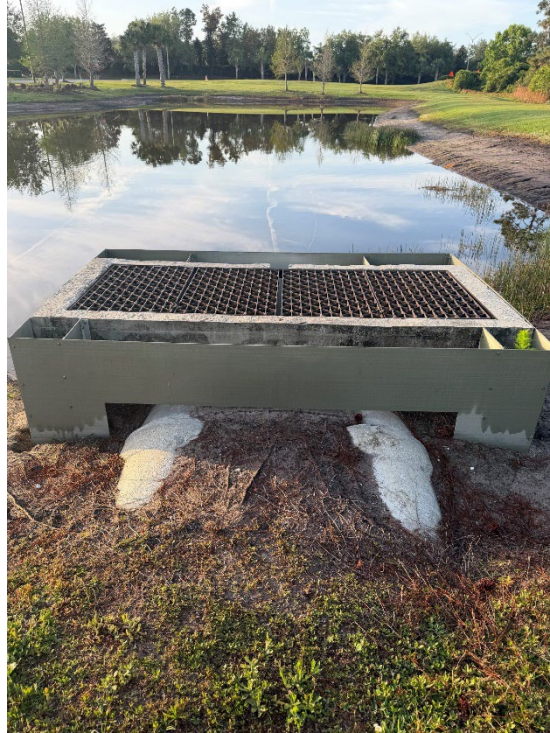
**Photo 3 – Water Control Structure in Good Condition (No Observed Changes)  
(Refer to Prior Photo 4 - 2025 Assessment)**

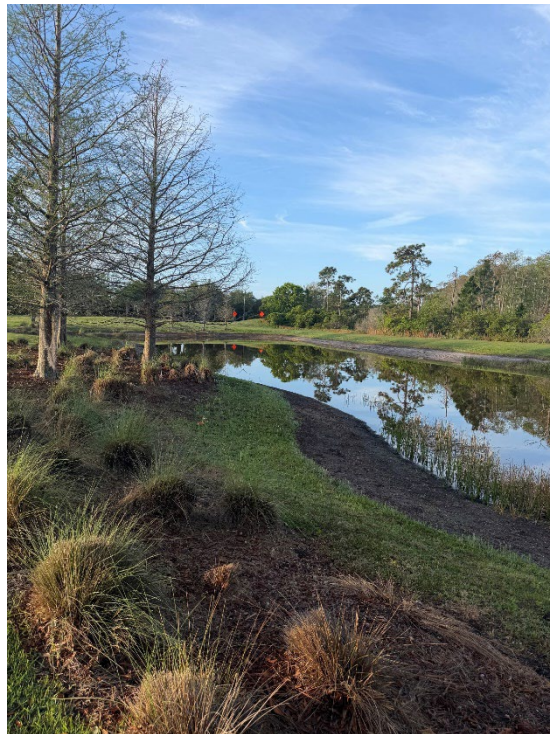
**Photo 4 – South Edge of Pond in Good Condition (No Observed Changes)  
(Refer to Prior Photo 5 - 2025 Assessment)**

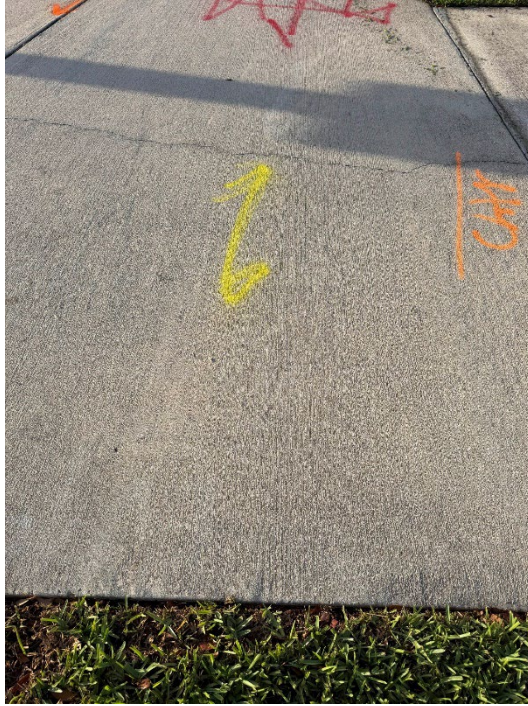
**Photo 5 – Surficial Concrete Cracking Beginning of Pedestrian Path  
Lake Nona Blvd & Nemours Parkway (No Observed Changes)  
(Refer to Prior Photo 6 - 2025 Assessment)**

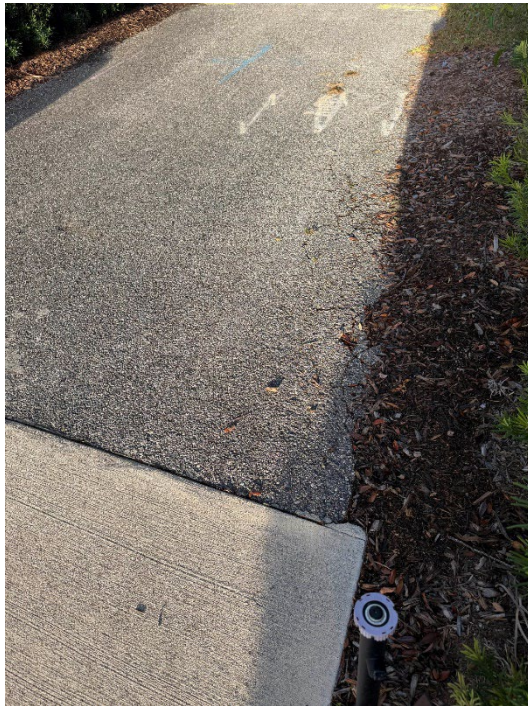
**Photo 6 – Typical Asphalt Raveling and Base Failure (No Observed Changes)  
(Refer to Prior Photo 7 - 2025 Assessment)**

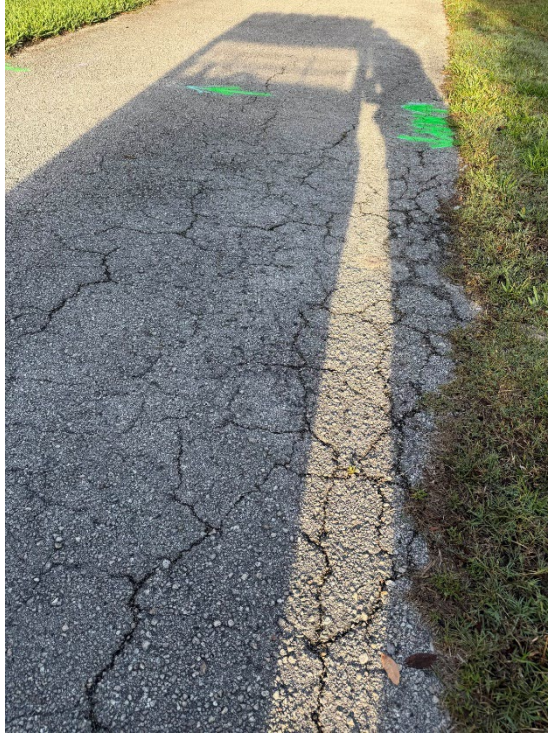
**Photo 6.1 – Typical Asphalt Raveling and Base Failure  
(New Photo – 2026 Assessment)**

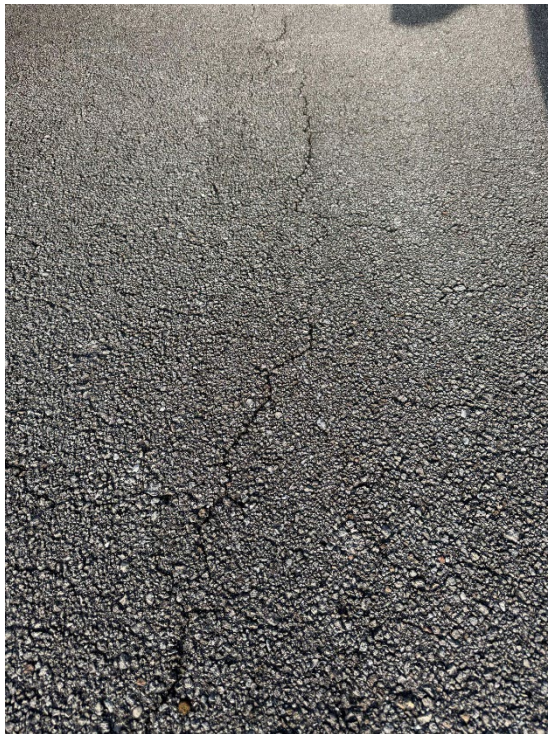
**Photo 7 – Typical Asphalt Raveling (No Observed Changes)  
(Refer to Prior Photos 8 and 9– 2025 Assessment)**

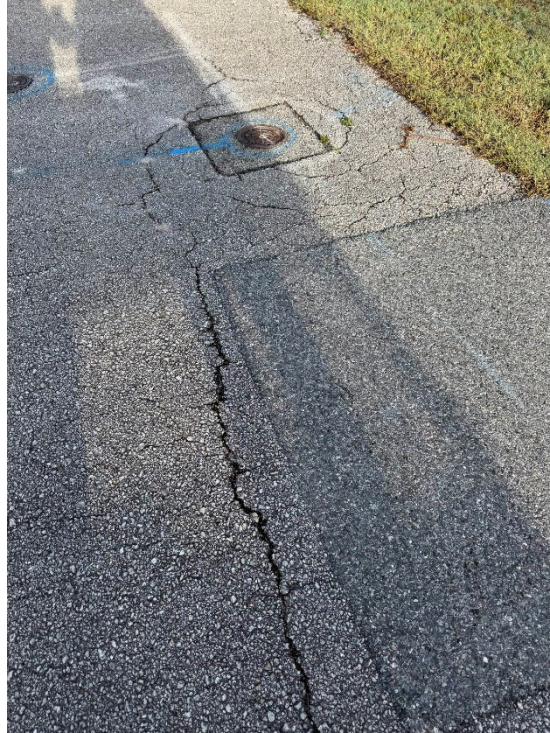
**Photo 7.1 – Typical Asphalt Failure  
(New Photo – 2026 Assessment)**

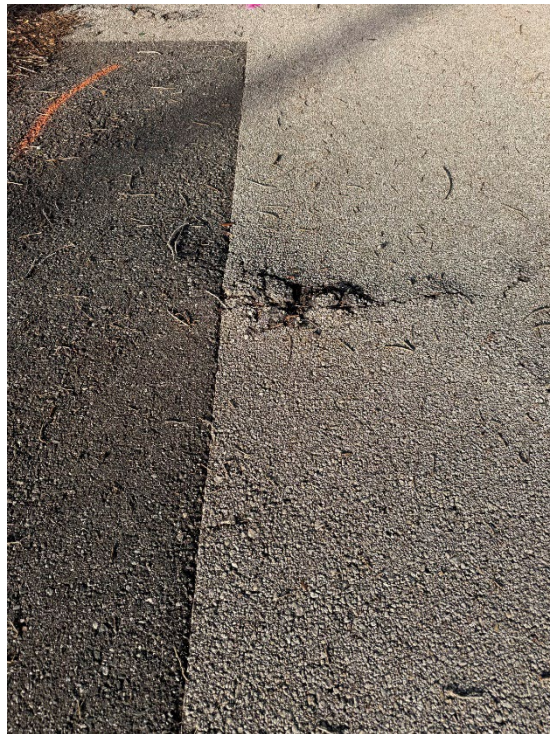
**Photo 8 – Tree Roots Damaging Asphalt (No Observed Changes)  
(Refer to Prior Photo 10 - 2025 Assessment)**

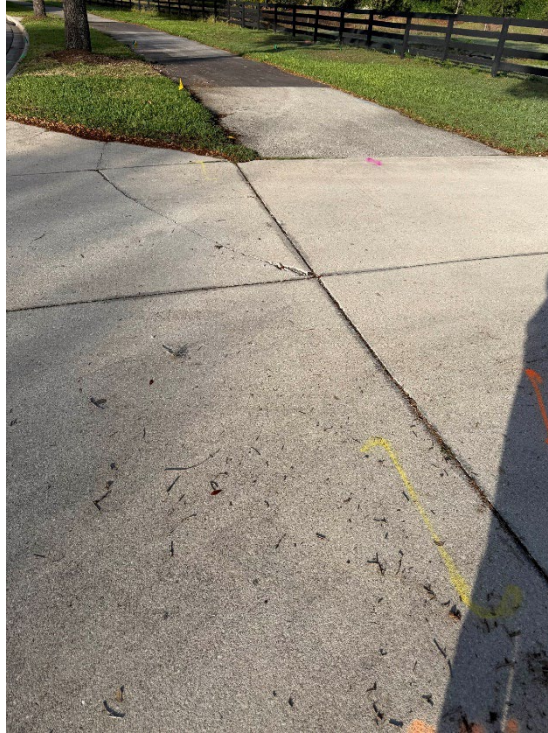
**Photo 9 – Surficial Concrete Cracks at Construction Entrance (No Observed Changes)  
(Refer to Prior Photo 11 - 2025 Assessment)**

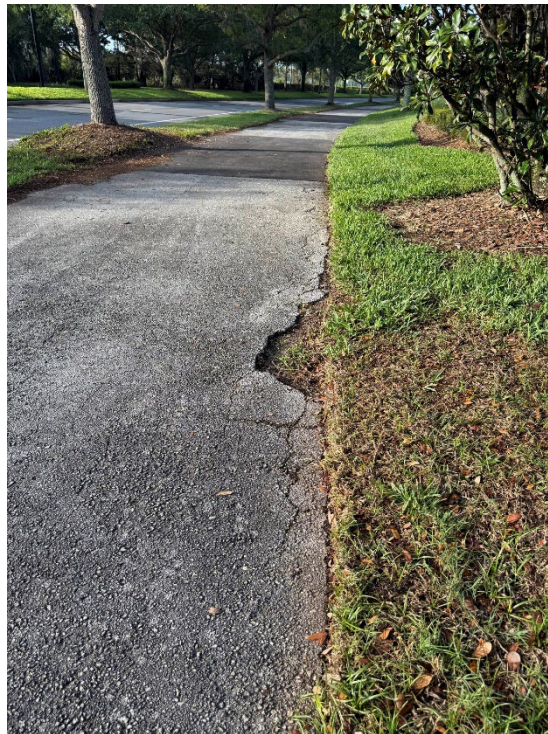
**Photo 9.1 – Asphalt Raveling and Base Failure  
(New Photo – 2026 Assessment)**

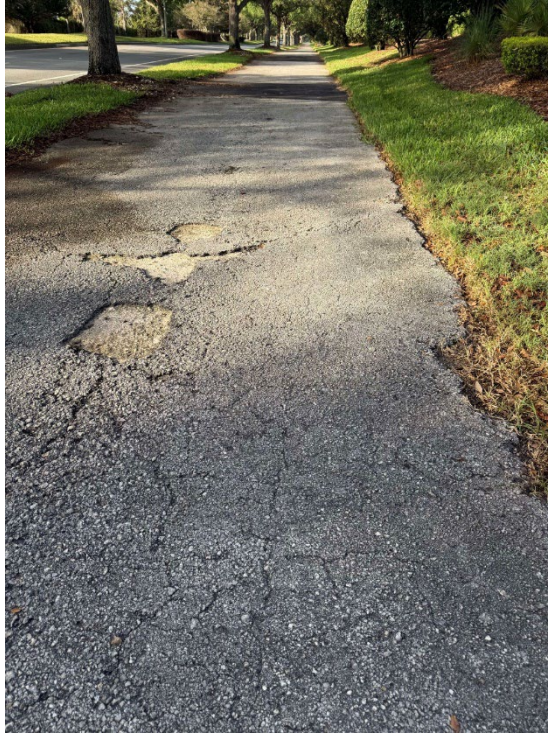
**Photo 10 – Asphalt Damage (No Observed Changes)  
(Refer to Prior Photo 12 – 2025 Assessment)**

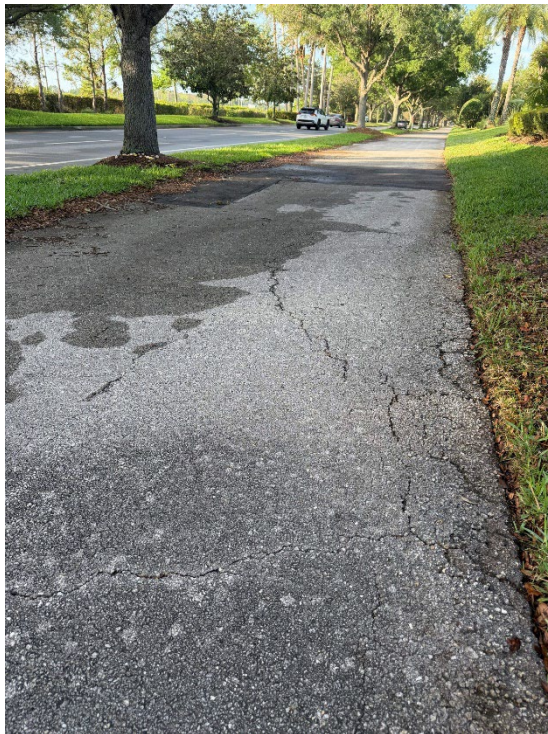
**Photo 11 – Tree Roots Damaging Asphalt, Asphalt Failure (No Observed Changes)  
(Refer to Prior Photo 13 - 2025 Assessment)**

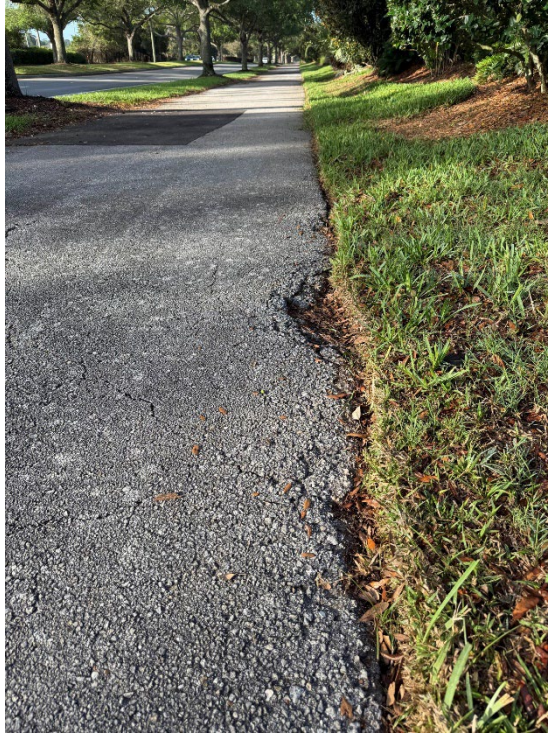
**Photo 11.1 – Typical Asphalt Raveling and Failure  
(New Photo – 2026 Assessment)**

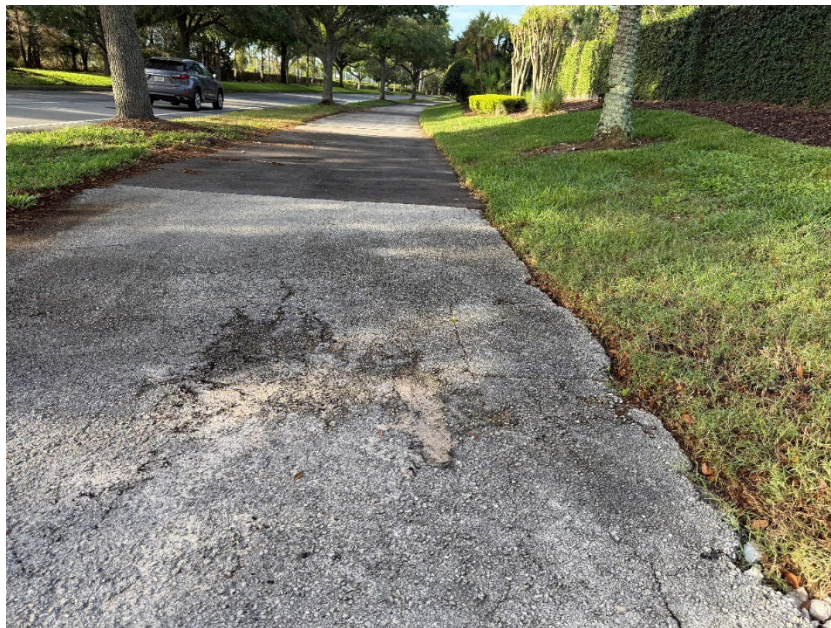
**Photo 11.2 – Additional Asphalt Damage and Base Failure  
(New Photo – 2026 Assessment)**

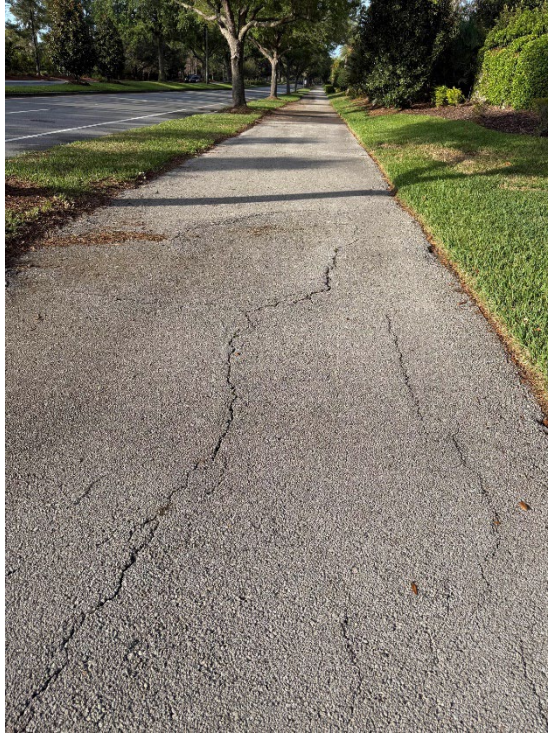
**Photo 11.3 – Asphalt Cracking  
(New Photo – 2026 Assessment)**

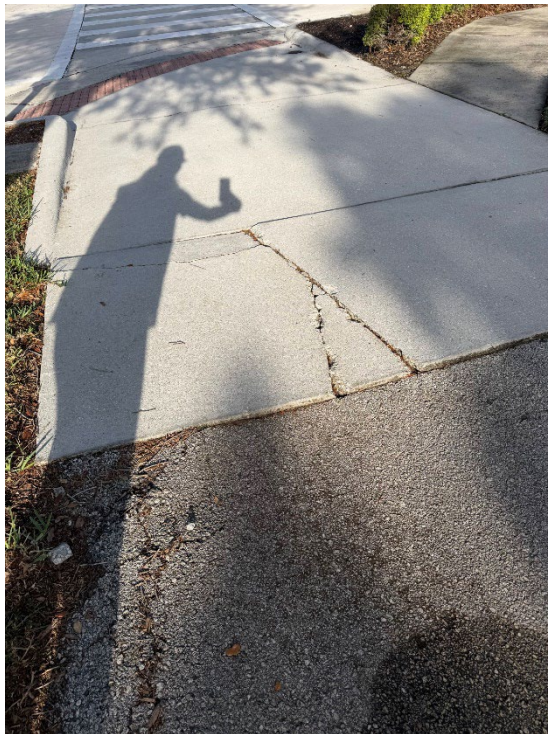
**Photo 11.4 – Cracked Concrete on Sidewalk  
(New Photo – 2026 Assessment)**

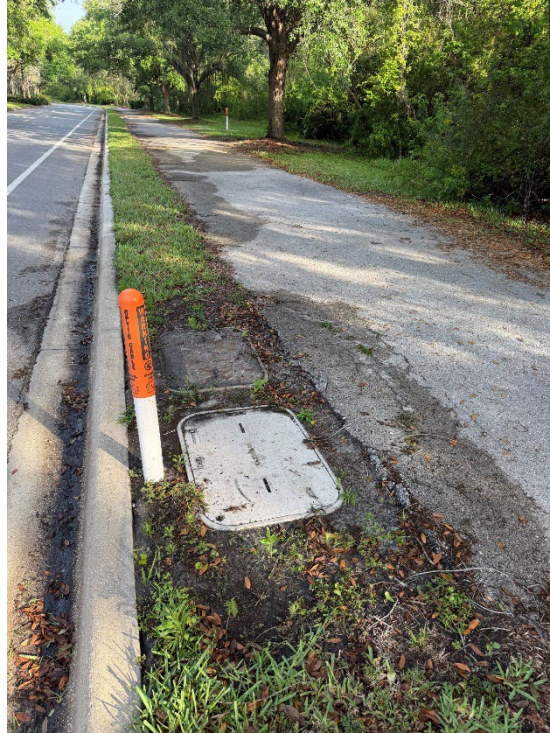
**Photo 12 – Asphalt Raveling and Base Failure at Meter Box (No Observed Changes)  
(Refer to Prior Photo 16 - 2025 Assessment)**

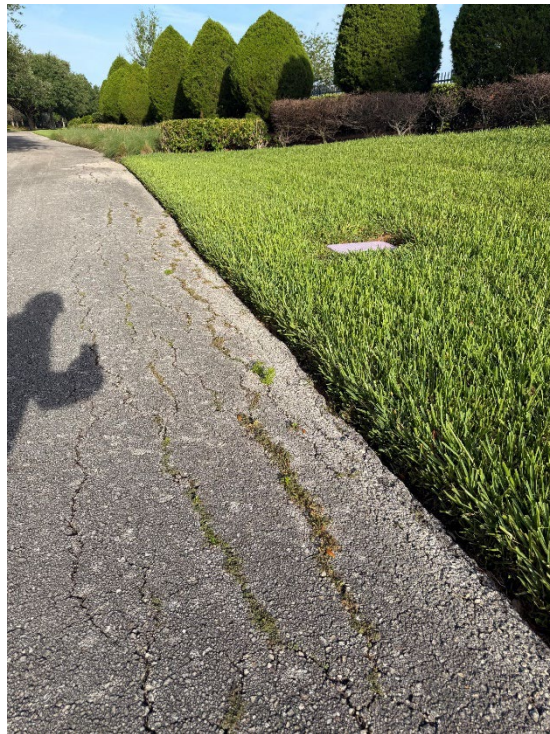
**Photo 13 – Asphalt Raveling and Base Failure (No Observed Changes)  
(Refer to Prior Photo 17 - 2025 Assessment)**

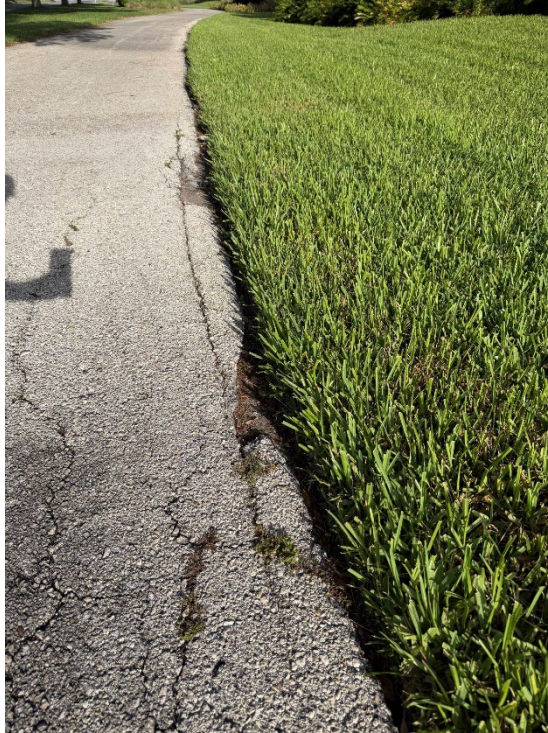
**Photo 14 – Asphalt Raveling and Base Failure (No Observed Changes)  
(Refer to Prior Photo 18 - 2025 Assessment)**

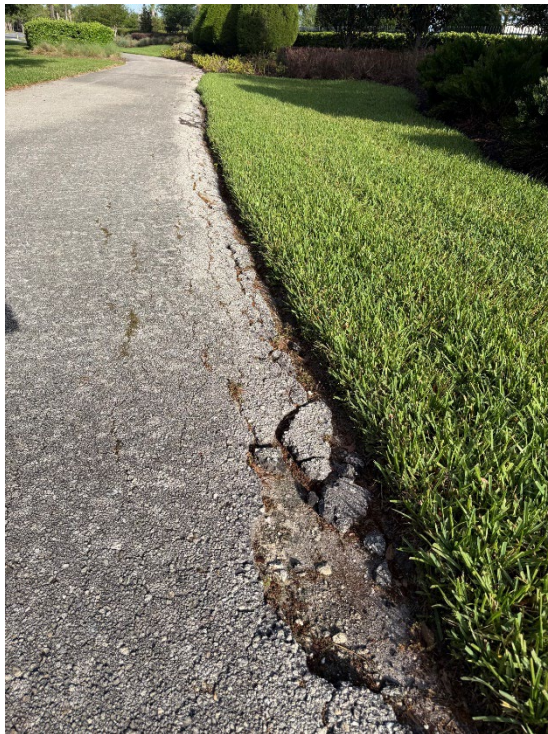
**Photo 14.1 – Asphalt Raveling and Base Failure  
(New Photo – 2026 Assessment)**

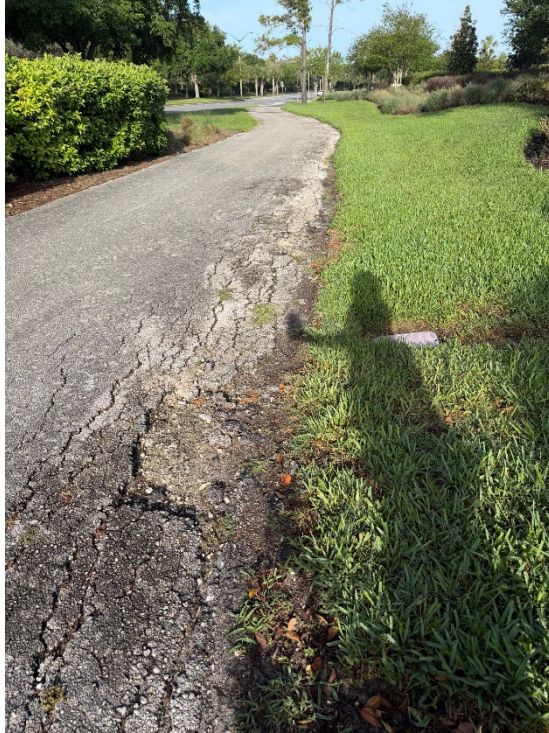
**Photo 15 – Asphalt Raveling and Base Failure (No Observed Changes)  
(Refer to Prior Photo 19 - 2025 Assessment)**

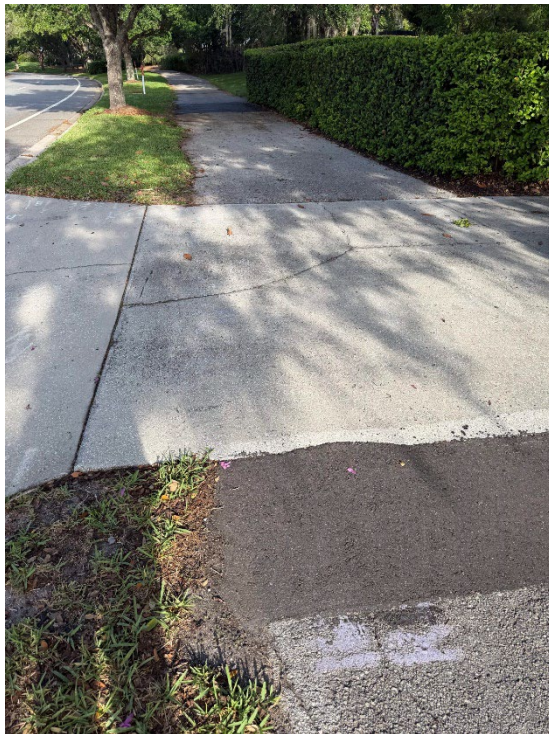
**Photo 16 – Surficial Concrete Cracked in Driveway Apron (No Observed Changes)  
(Refer to Prior Photo 20 - 2025 Assessment)**

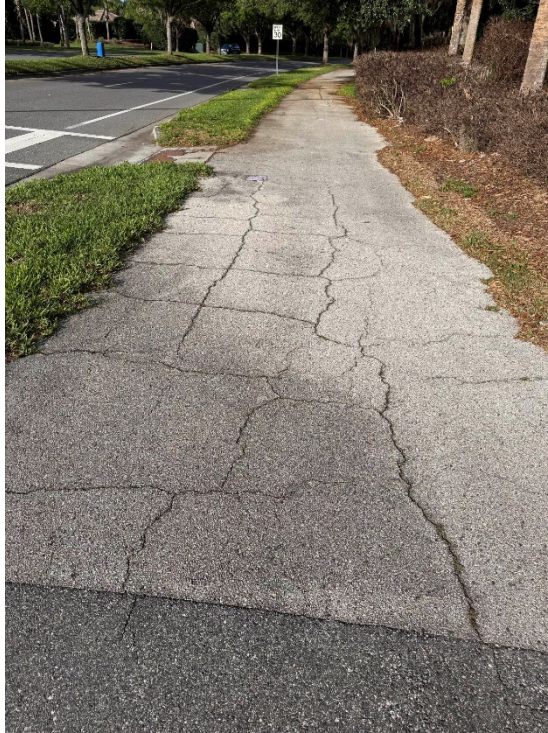
**Photo 17 – Alligator Cracking (No Observed Changes)  
(Refer to Prior Photo 21 - 2025 Assessment)**

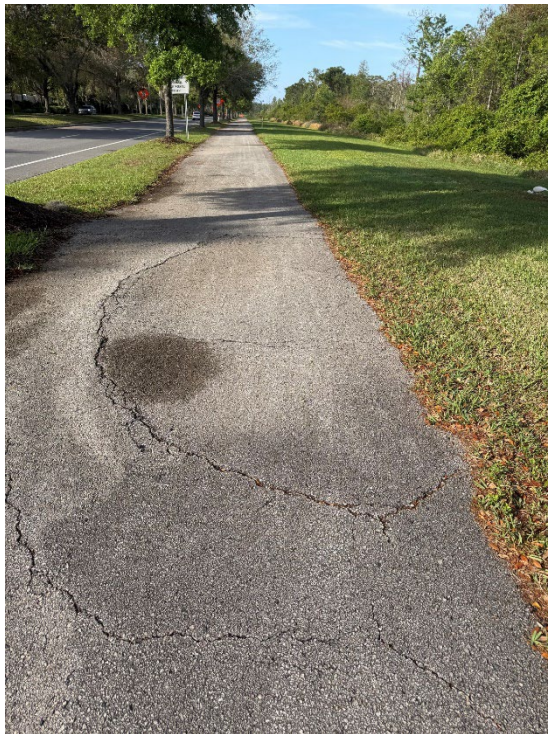
**Photo 17.1 – Asphalt and Base Failure  
(New Photo – 2026 Assessment)**

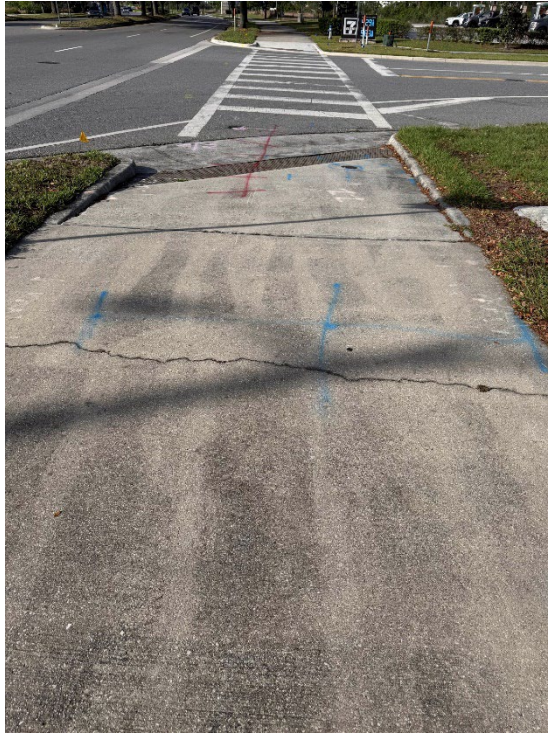
**Photo 18 – Surficial Cracked Concrete (No Observed Changes)  
(Refer to Prior Photo 25 - 2025 Assessment)**
